# Appendices

## Appendix A: Water System Facilities Records

RE: **Well & Pump Station Evaluation**  
**City of Ammon – Well #6 Design & Remodel #213072-000**

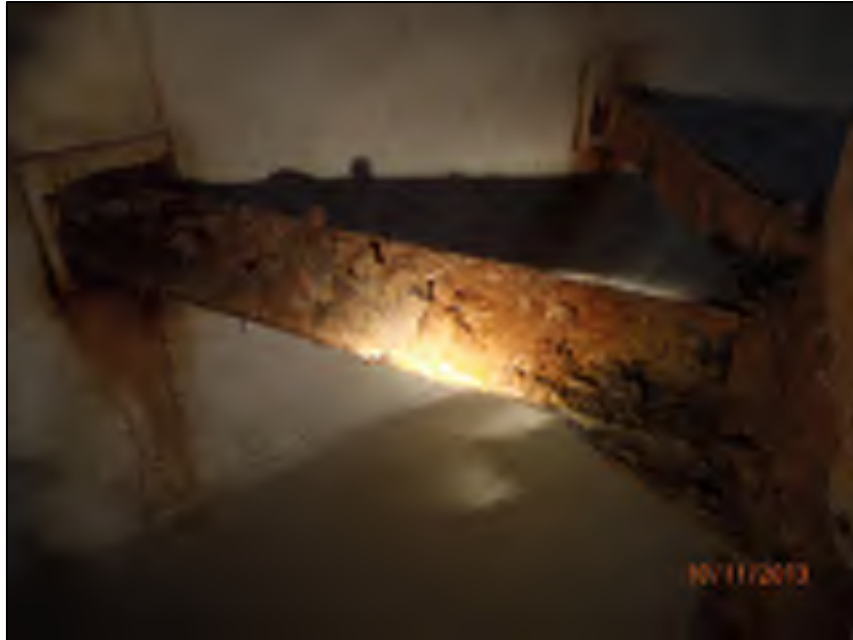
The drain pipe, inlet pipe, and outlet pipe have minimal corrosion typical of ductile iron piping inside reservoirs. The degree of corrosion is not detrimental to the pipe and can be easily remedied during cleaning. The overflow pipe and its supports have varying degrees of corrosion. There is a significant amount of pack rust occurring at the pipe flanges and bolts. There is also a significant amount of rust buildup at all overflow pipe supports. This can be attributed to the carbon steel supports and bolts with limited or no coating. All bolts and overflow piping supports should be removed and replaced with stainless steel hardware. Rusting on the ductile iron flanges and piping should be remedied during cleaning.

**Close-up of rusting pipe supports**

- Sand is an ongoing maintenance issue, and should be removed during inspections to observe the condition of the floor and the wall-to-base joint.
- Replace all overflow pipe supports and bolts associated with overflow piping with stainless steel hardware. Clean and remove rust buildup on overflow pipe, specifically at pipe flanges.

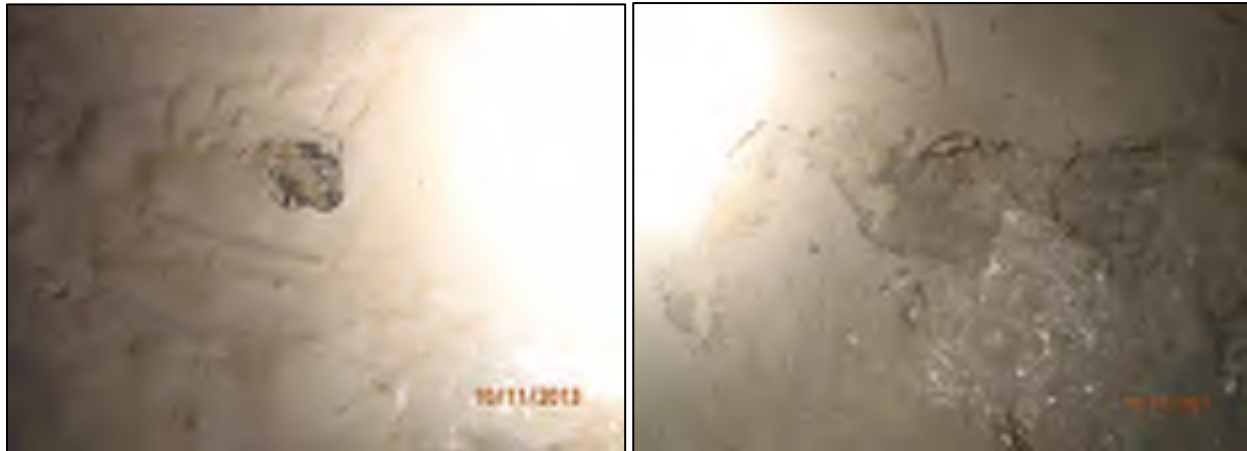
looking at the coating, it appears it may have been a grout epoxy mix to infill voids and provide added water tightness. In many locations, the outer layer of the coating has boiled. Portions of the coating were removed, revealing water between the coating and concrete wall at these boiling locations. However, no cracking or spalling of the coating was noted and in all locations the wall appears to be sound and in good condition.

**Boiling of coating removed; concrete appears to be in sound condition underneath**

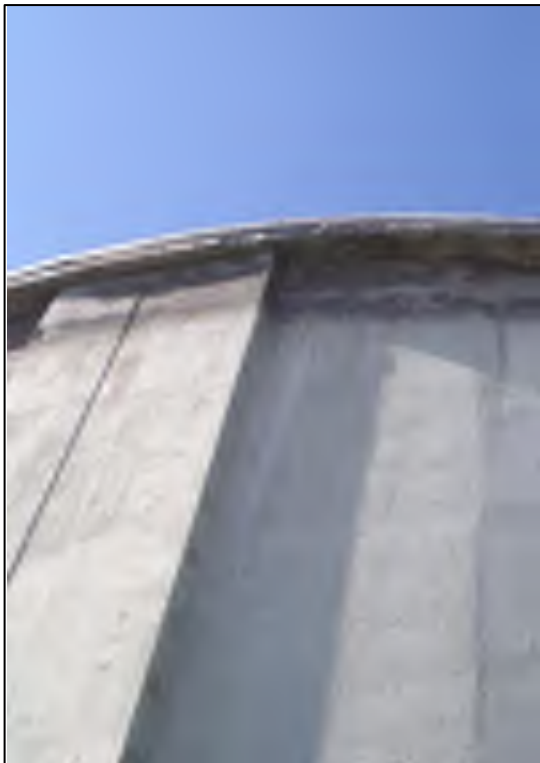
**Exterior pilaster and underside of roof overhang, minor scaling at roof**

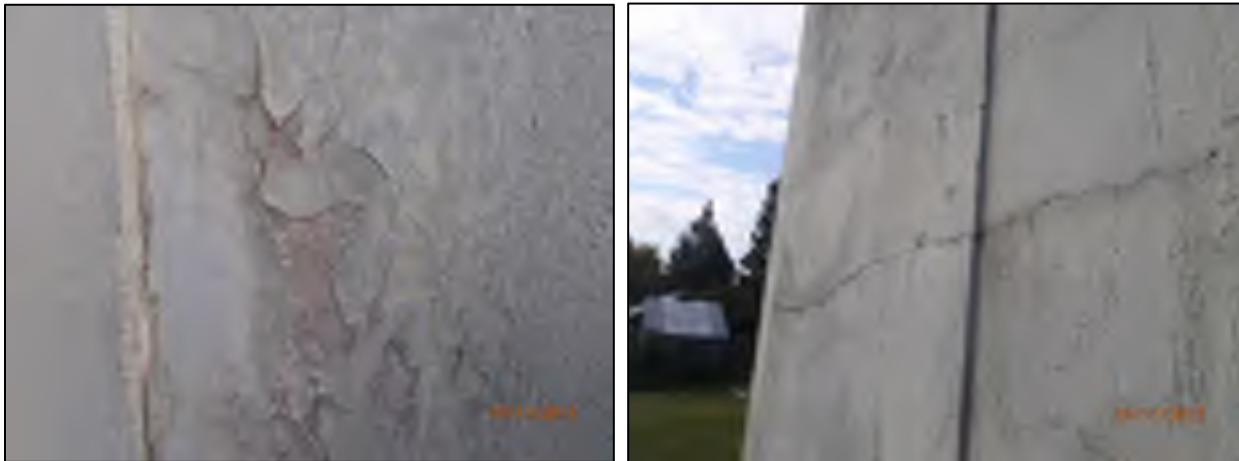
Most of the exterior wall is above grade, with the bottom three feet buried. The exterior of the wall has an aesthetic sack finish and coating applied. No signs of deterioration with the prestressing tendons were visible. The prestressing tendons are encapsulated in concrete and terminate at each pilaster. The pilasters and exterior wall exhibit minor cracking, mostly in the outer concrete sack finish that has since been coated. There are locations where the sack finish/coating is no longer bonded to the structural concrete and has spalled off and/or cracked. These cracks are superficial and do not extend into the core wall. A few locations exhibited minor leaching and or damp spots. No observable leaks were present. The concrete wall appears to be sound and in good condition; however, the aesthetic finish will continue to deteriorate over time and may need replaced at some future time as deemed necessary by the City.

**Surface scaling and cracking occurring in sack finish and coating**

- Consider providing proper drain outflow to allow complete drainage of tank without pumping.
- The exterior coating and sack finish is primarily an aesthetic feature; ongoing maintenance and/or replacement of finish to be completed as necessary by the City.

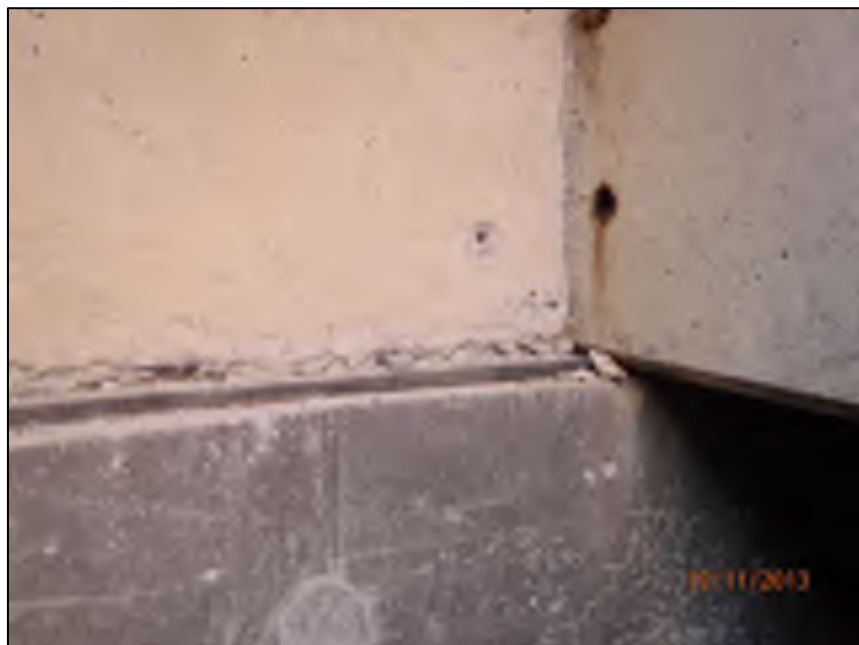
The roof-to-wall joint was inspected from both the inside and outside of the tank. This joint is considered to be a flexible joint. Around the perimeter of the tank, the roof double tee beams bear directly on a wide neoprene pad centered at the top of the wall panel. Between the double tees, the void is infilled with reinforced concrete to match the thickness and circumference of the wall below. It does appear that this joint allows lateral movement between the wall and roof joint, enabling the structure to expand and contract. However, it is unknown if any type of vertical dowel exists to restrain against excessive movement during dynamic loading in the event of an earthquake; hence some vulnerabilities may be present.

**Roof-to-wall joint**

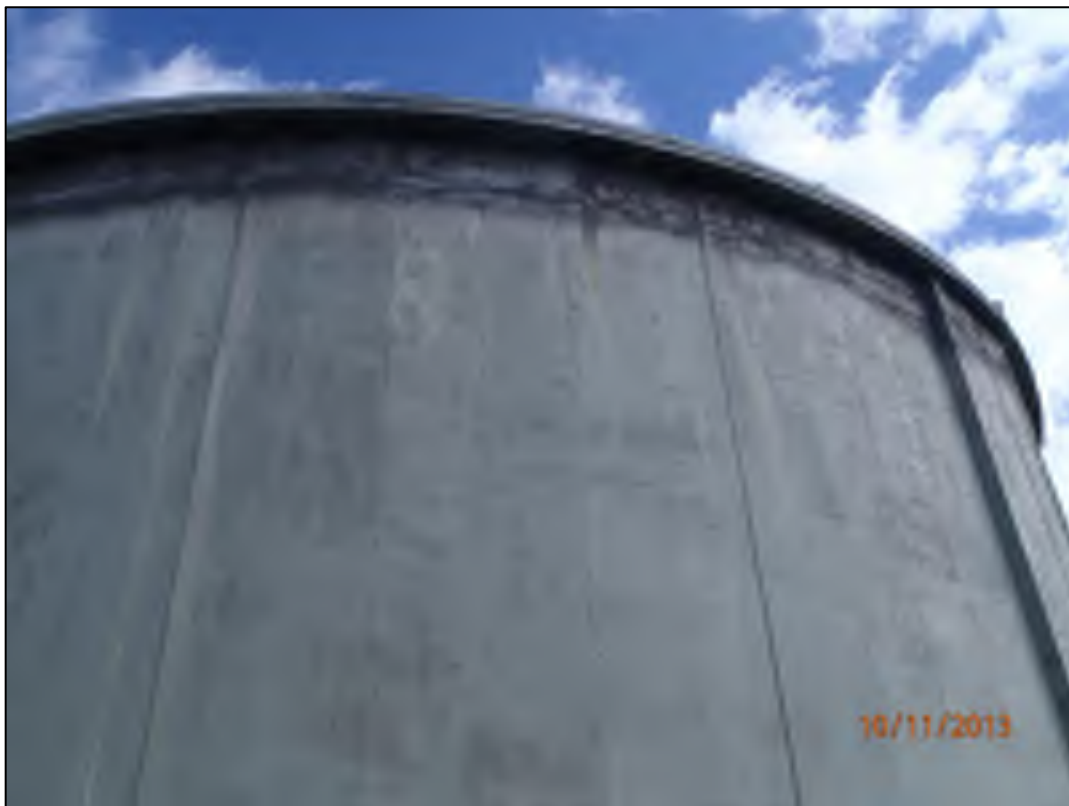
At the exterior, the roof-to-wall joint appears to have been patched and sack finished. Cracking is occurring in the patchwork, and some minor spalling at the top of wall exists. Cracking will continue to be an

ongoing problem at this location due to the flexible nature of the joint. Minor spalling may also occur at the top of wall/concrete infill. Ongoing maintenance may be required, but overall, the wall and roof joint appear to be in sound condition for static loading conditions.

**Patching at roof-to-wall joint experiencing moderate deterioration**

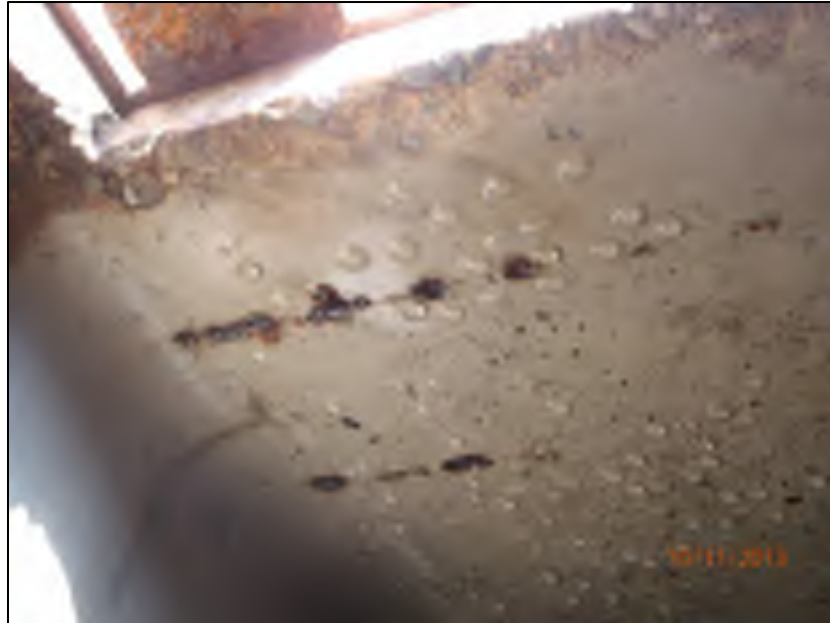
**Rusting of reinforcing on underside of roof slab, lack of concrete cover**

- Repair and patch reinforcing and concrete infill between double tee beams where reinforcing is exposed and rusting.
- Replace tar and gravel roof with new membrane roof.

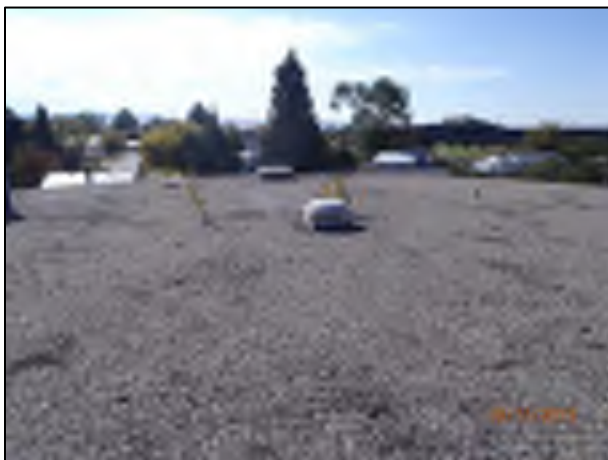
The concrete double tee roof appears to be covered with a tar and gravel roof. A tar and gravel roof consists of layers of asphalt and tar paper adhered with applications of molten asphalt. It appears that, for this application, a one-inch layer of sand was used between layers of asphalt tar paper. The laminated layers then received a top finish of gravel, some of which became embedded in the hot asphalt, and some of which lies loose on the surface of the roof. The purpose of the gravel is to shield the asphalt from the damaging effect of sun exposure. Over the years, many small trees have sprouted up in various locations, and seams of the tar paper have separated. From discussions with City staff little to no maintenance on the roof has been performed over the years, indicating this is likely the original roofing. The life expectancy of a tar and gravel roof is 20 years; this roof has far exceeded the normal life span. Keller Associates recommends the roofing system be replaced.

**Tar and gravel roofing with tree growth**

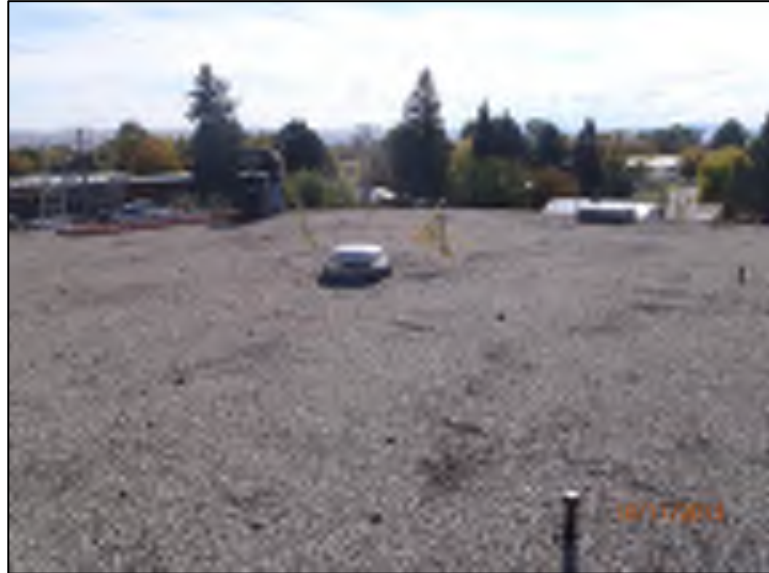
The vent in the roof appears to be in adequate condition. The ventilator is not secure against vandalism, and could allow dust and other contaminants to get into the reservoir. Keller Associates recommends the vent be replaced with a security vent to prevent contamination of the reservoir.

**Roof access hatch and vent**

There is one manway access hatch into the tank on the south side of the roof. The hatch appears to be in adequate condition, and provides a lip over the edge to prevent exterior water intrusion. No locking mechanism exists. Keller Associates recommends the hatch be modified to incorporate a lock to prevent against vandalism.

- Replace roof vent with new security roof vent.
- Provide locking mechanism on access hatch.
- Provide new fine screen on overflow outflow.
- Consider lowering the top of outlet pipe to increase usable storage. Maintain penetration through floor with a minimum of 8" clear from top of slab.

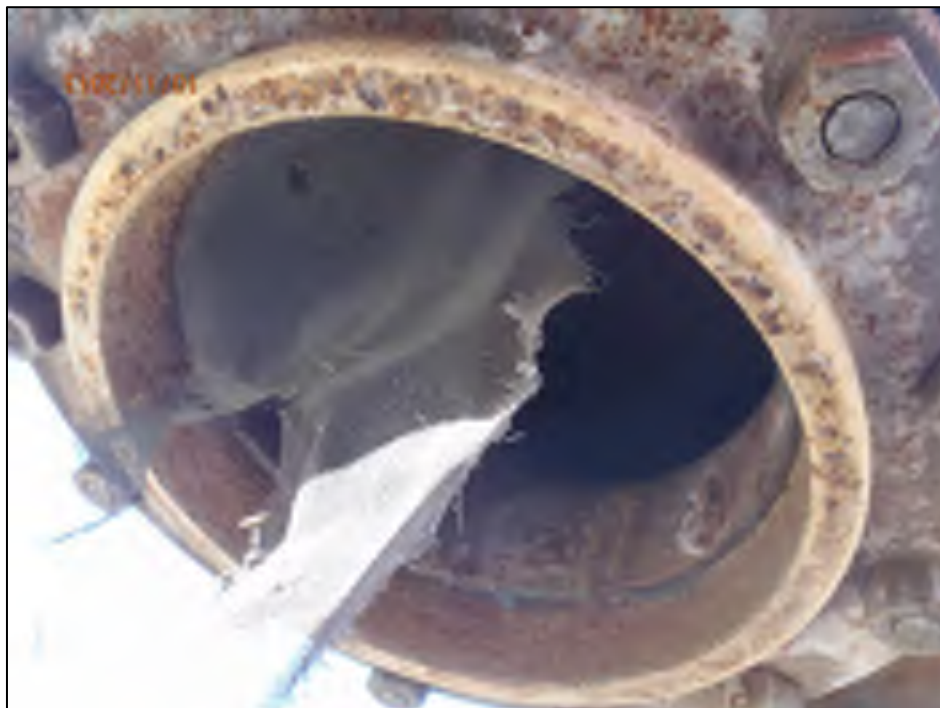
The termination of the overflow was observed; the fine mesh screening was damaged and did not enclose the pipe. The fine mesh screen should be replaced to prevent intrusion into the tank.

**Overflow outflow mesh is damaged**

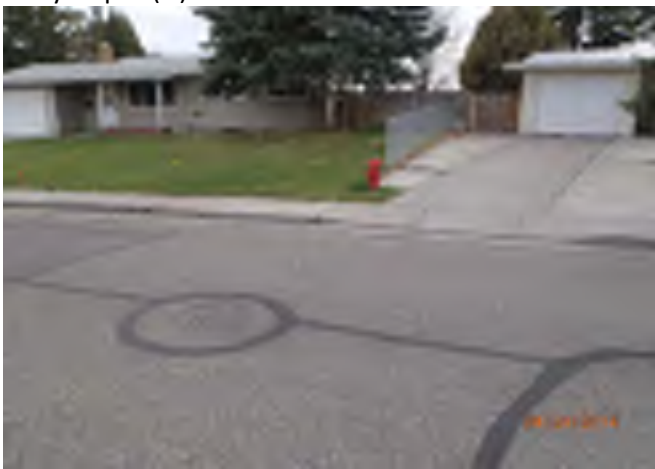
Hydrant ID: M15-015 \*DAMAGED  
Manufacturer: Pacific States  
Year: 1956  
Bury Depth (ft):
